GEOTECHNICAL INVESTIGATION & REPORT

WASHOUGAL RIVER ROAD
FANNING HILL SLIDE AT MP 13, CRP 1006.2 - PHASE I
SKAMANIA COUNTY, WASHINGTON

9-61M-10402-0

March 2000

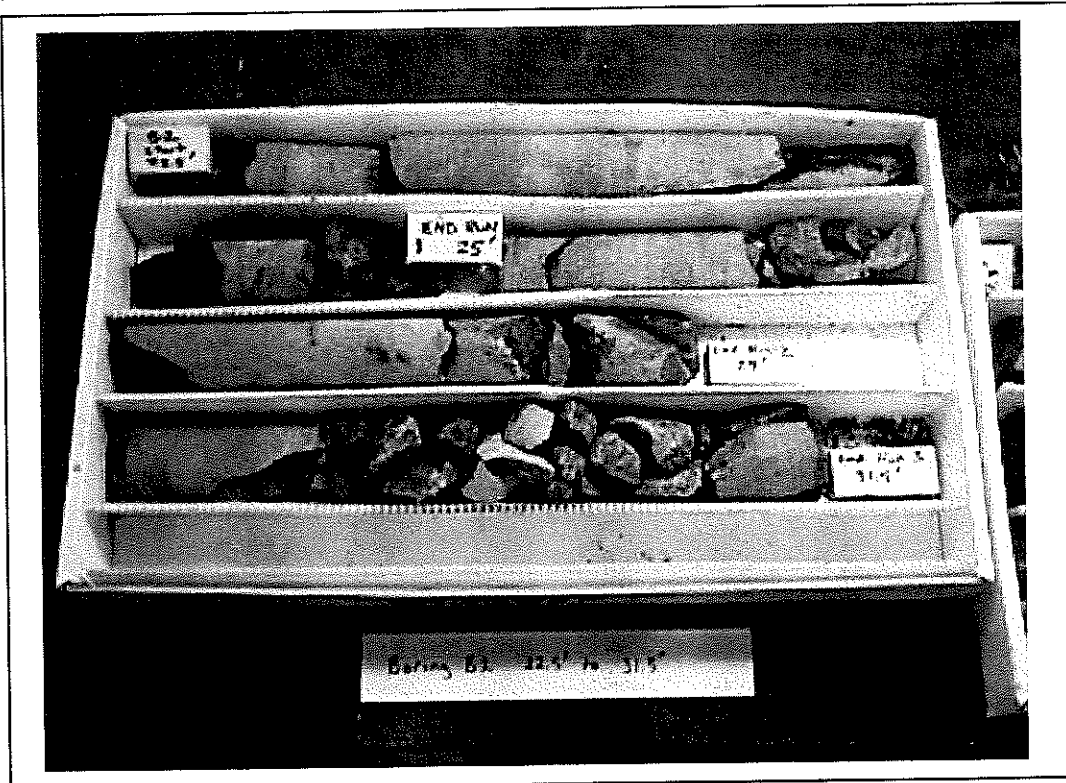
B2 - Rock cores from 22.5' - 31.5'.

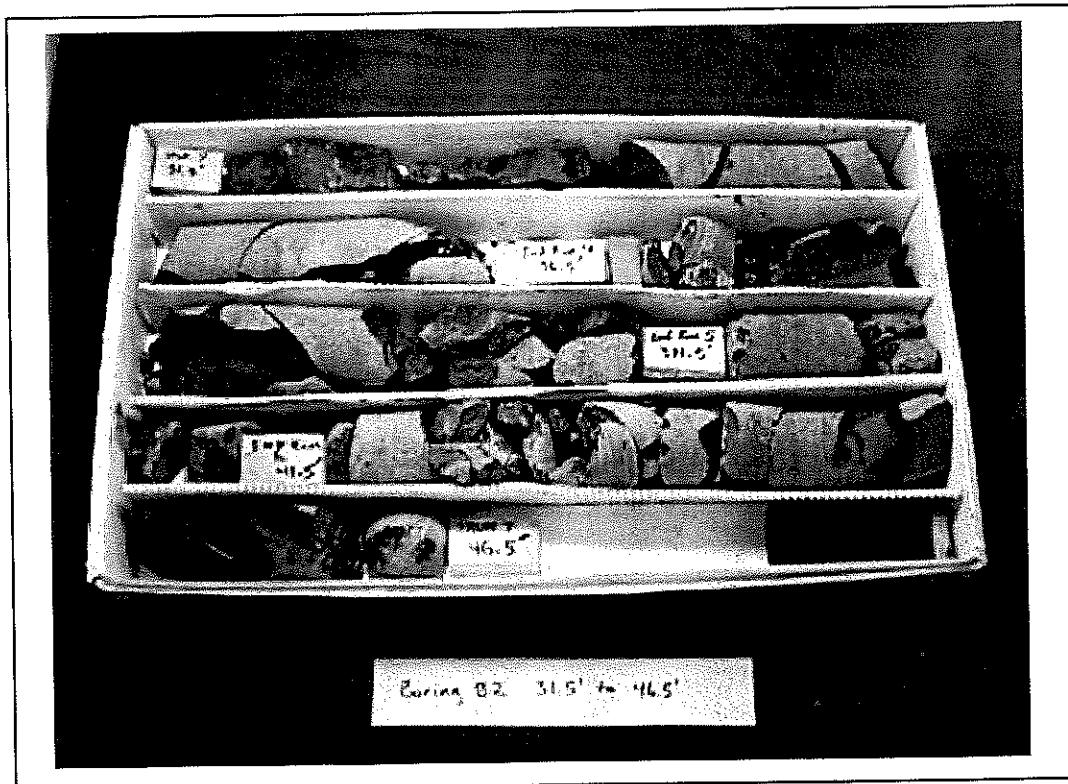
B2- Rock cores from 31.5' - 46.5'.

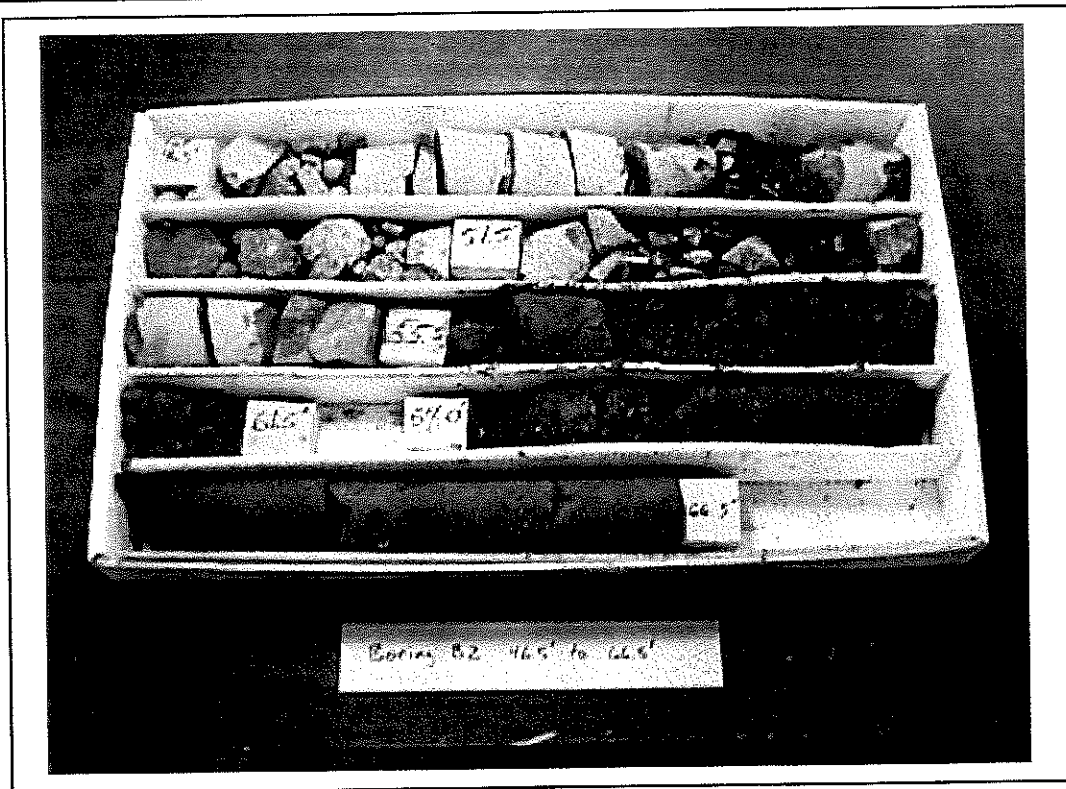
B2 - Rock cores from 46.5' - 66.5'.

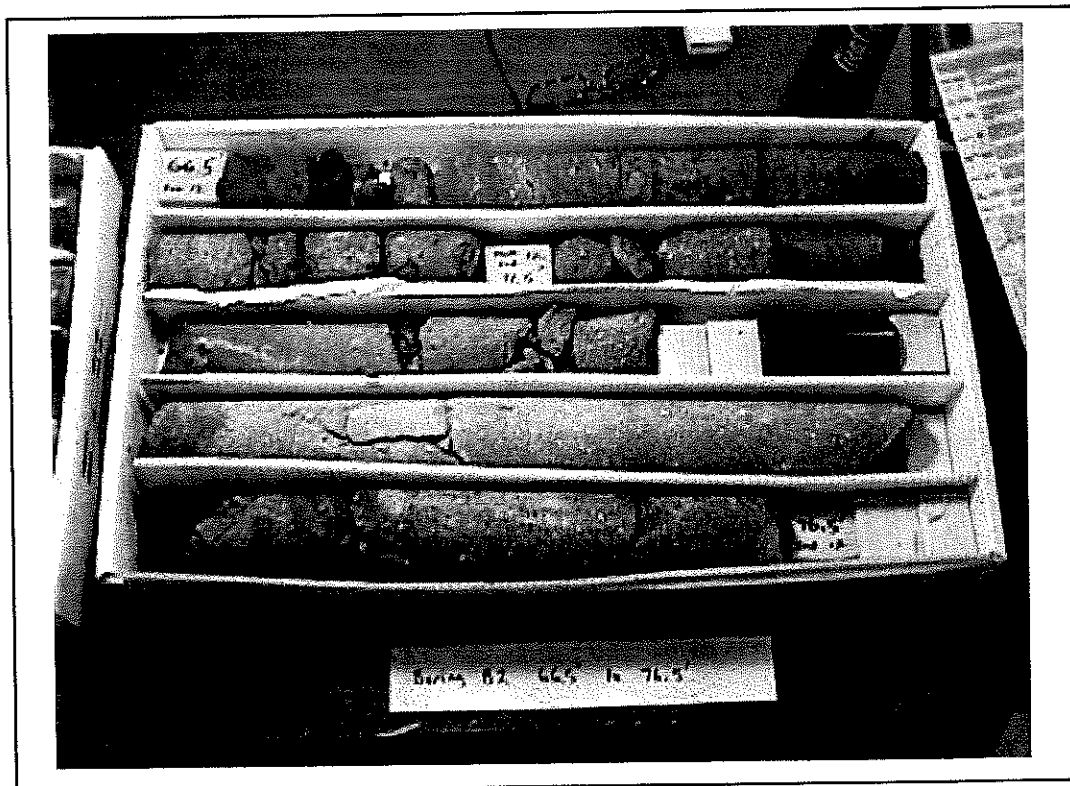
70	Dense, damp, black, silty CLAY, moderately cemented, high charcoal content. Landslide slip contact between a depth of 69 to 70 feet below ground surface. Weak (R2) VOLCANIC BRECCIA, green to reddish brown, very thinly bedded fine sand and clay with flow banding. Hydrothermally altered with abundant chlorite. Slickensides observed at 70 feet. (Altered flow breccia). Weak to medium strong (R2-R3) VOLCANIC TUFF, green, thin bedded, coarse to fine sand and silt. Hydrothermally altered with abundant chlorite.			Run 12					
75	Strong to very strong (R4-R5) BASALT, green, slightly weathered, highly vesicular and closely jointed. Vesicles are partially filled with chlorite. Joints and fractures are predominantly planar and rough.			Run 13					Lower vibrating wire piezometer at 72 feet
80	Hydrothermally altered with abundant chlorite and epidote. Trace native pyrrhotite on joints and fractures.			Run 14

B2- Rock cores from 66.5' - 76.5'.

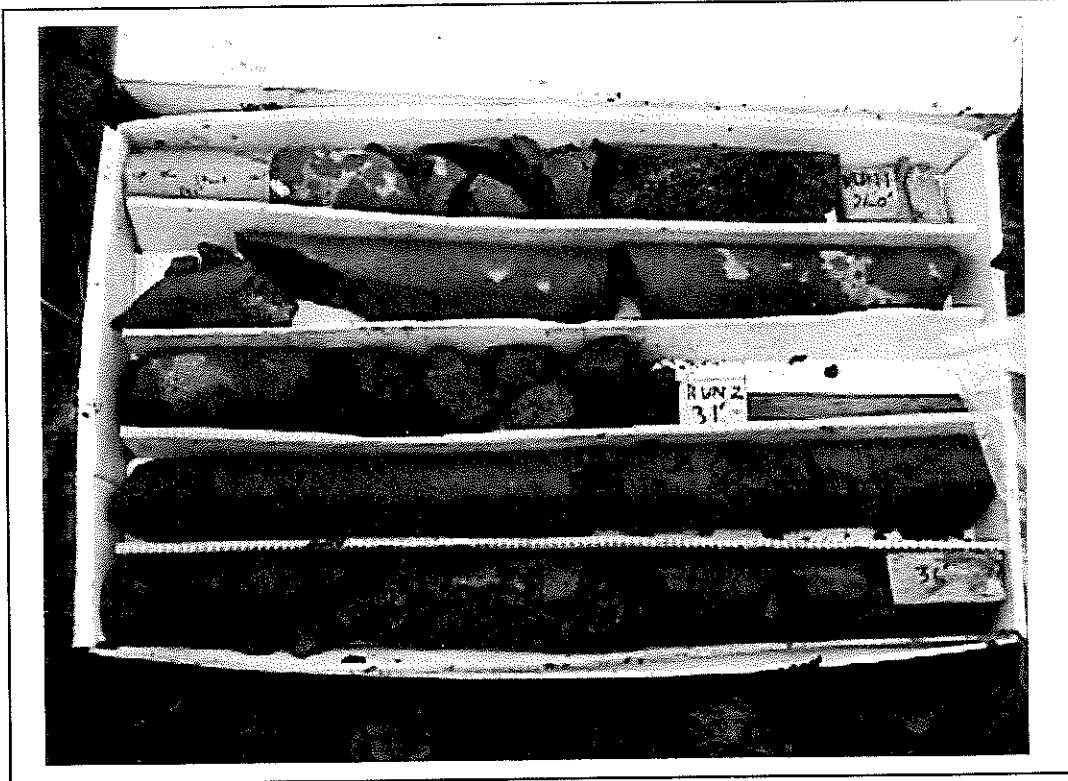
B3 - Rock cores from 24.5' - 41'.

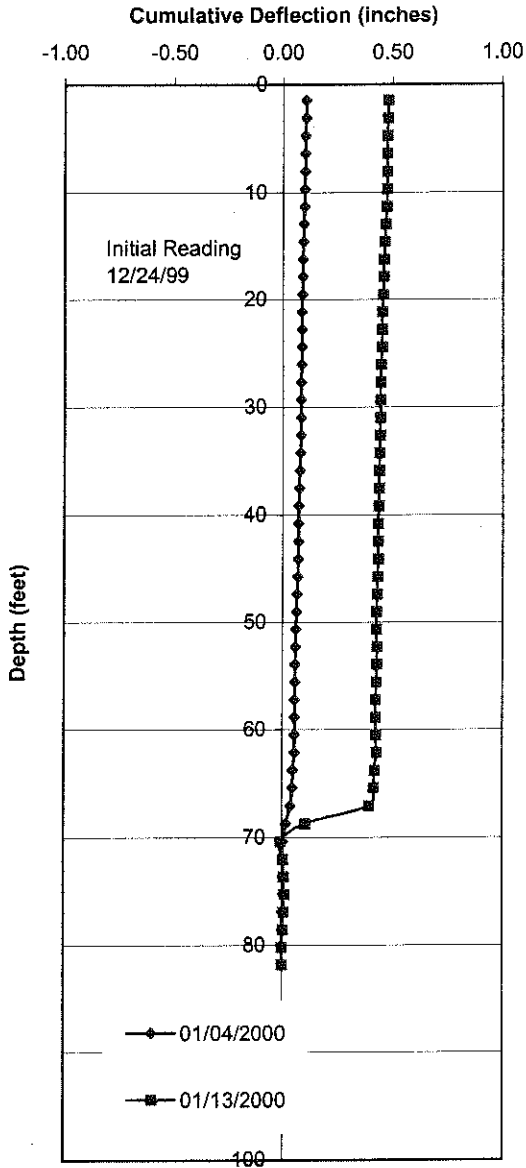
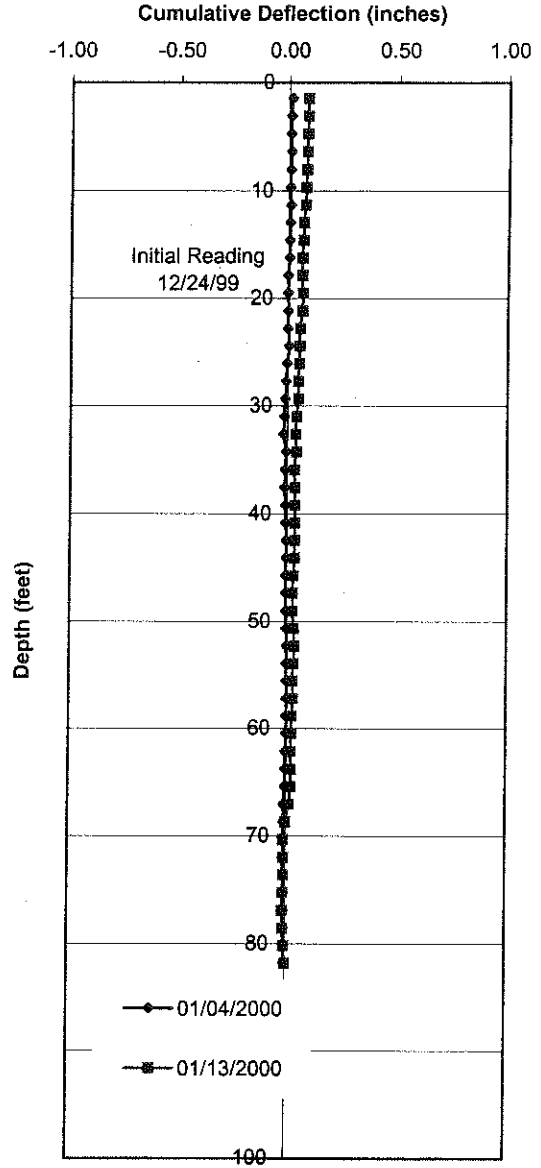
FIGURE A7

Inclinometer B2 shows a distinctive movement at a depth of 69 to 70 feet below the existing ground surface. Inclinometer B3 shows a slight backtilting at a depth of 22 feet that may be due to the vertical downward movement of a graben at this location. Based on the inclinometer data, the depth of movement is approximately 70 feet below the road surface. Figure 6 shows our interpreted subsurface section and failure surface.

B-2 - INCLINOMETER DATA

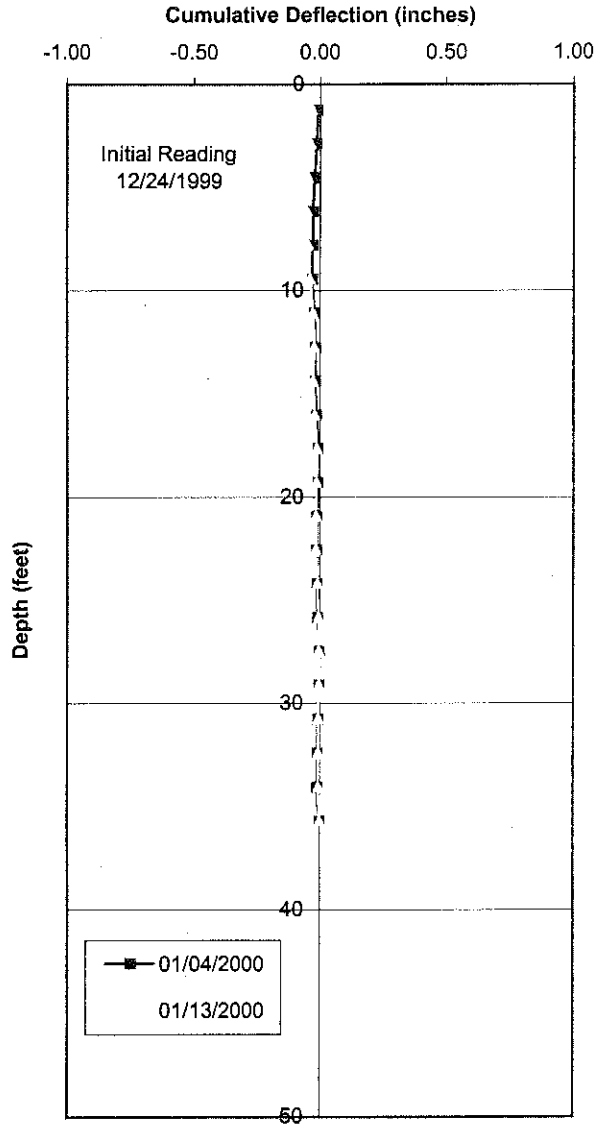
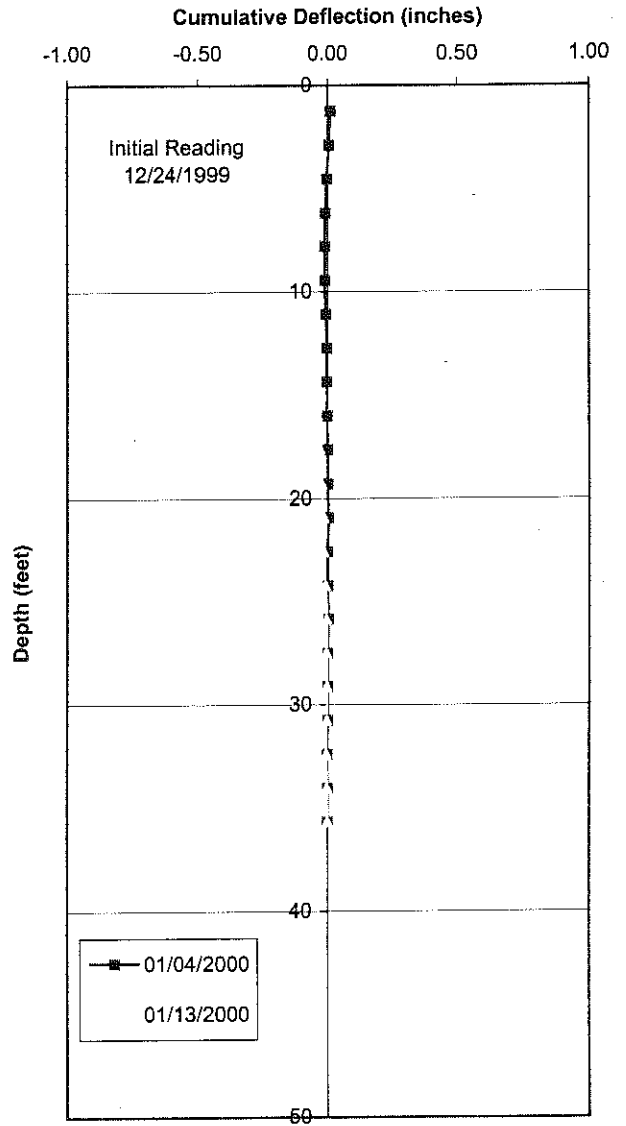
FIGURE A8

B-3 - INCLINOMETER DATA

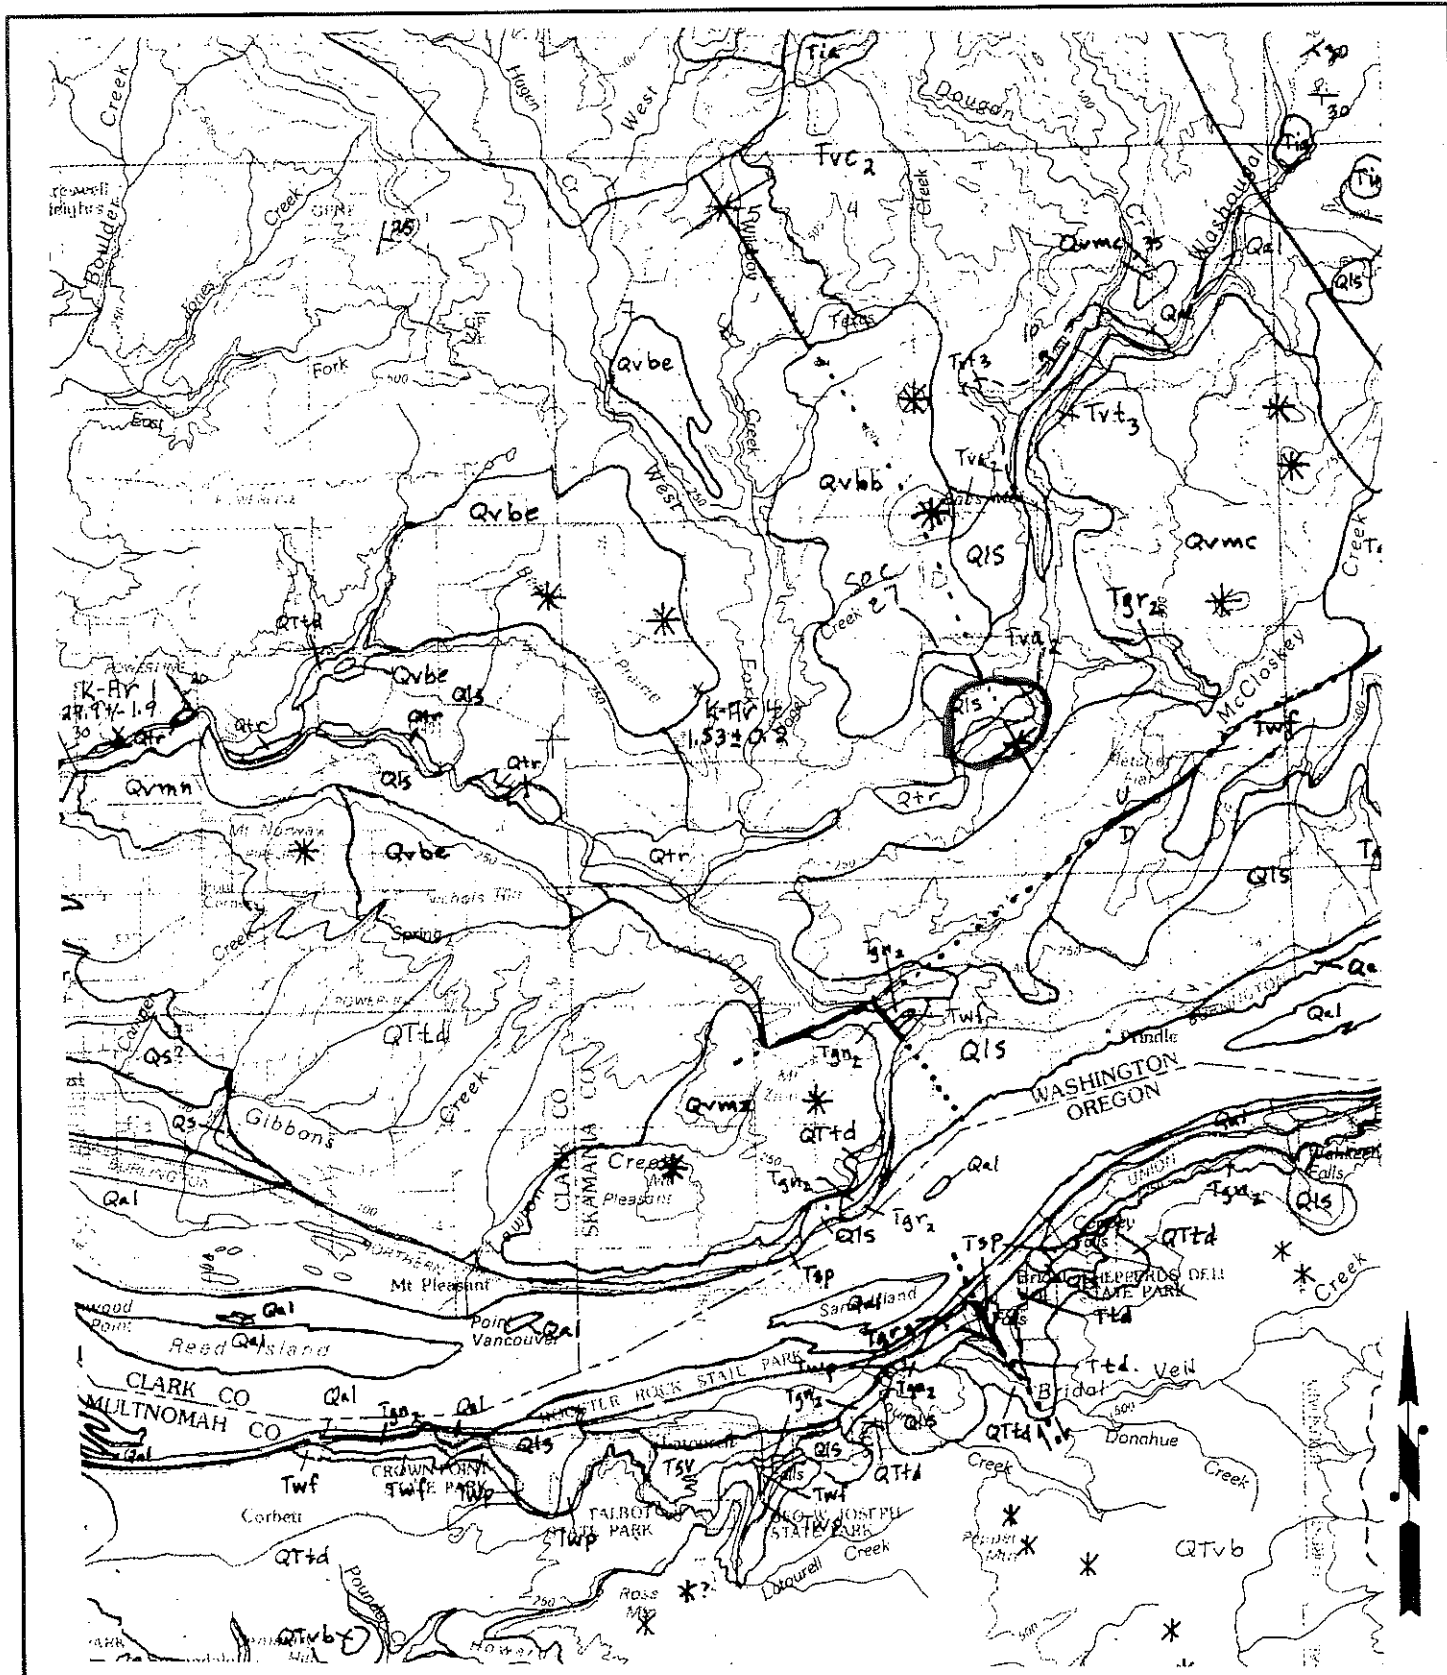
FIGURE 3

The MP 13 landslide site and surrounding area is mapped as Qls, landslide terrain in the Geologic literature (Figure 3). As shown, the road cuts across the southern edge of a large landslide that covers a majority of T2N, R5E, Section 27. The active portion of the MP 13 landslide which has a significant effect on the road is limited to the extreme southwest lobe of a much larger ancient landslide (Figure 4).
