**GEOTECHNICAL ASSESSMENT; SKAMANIA QUARRY; SKAMANIA COUNTY, WASHINGTON
PREPARED BY NV5
DATED AUGUST 17, 2021**

August 17, 2021

Geotechnical Assessment
 Skamania Quarry
 Skamania County, Washington
 Project: Storedahl-12-01

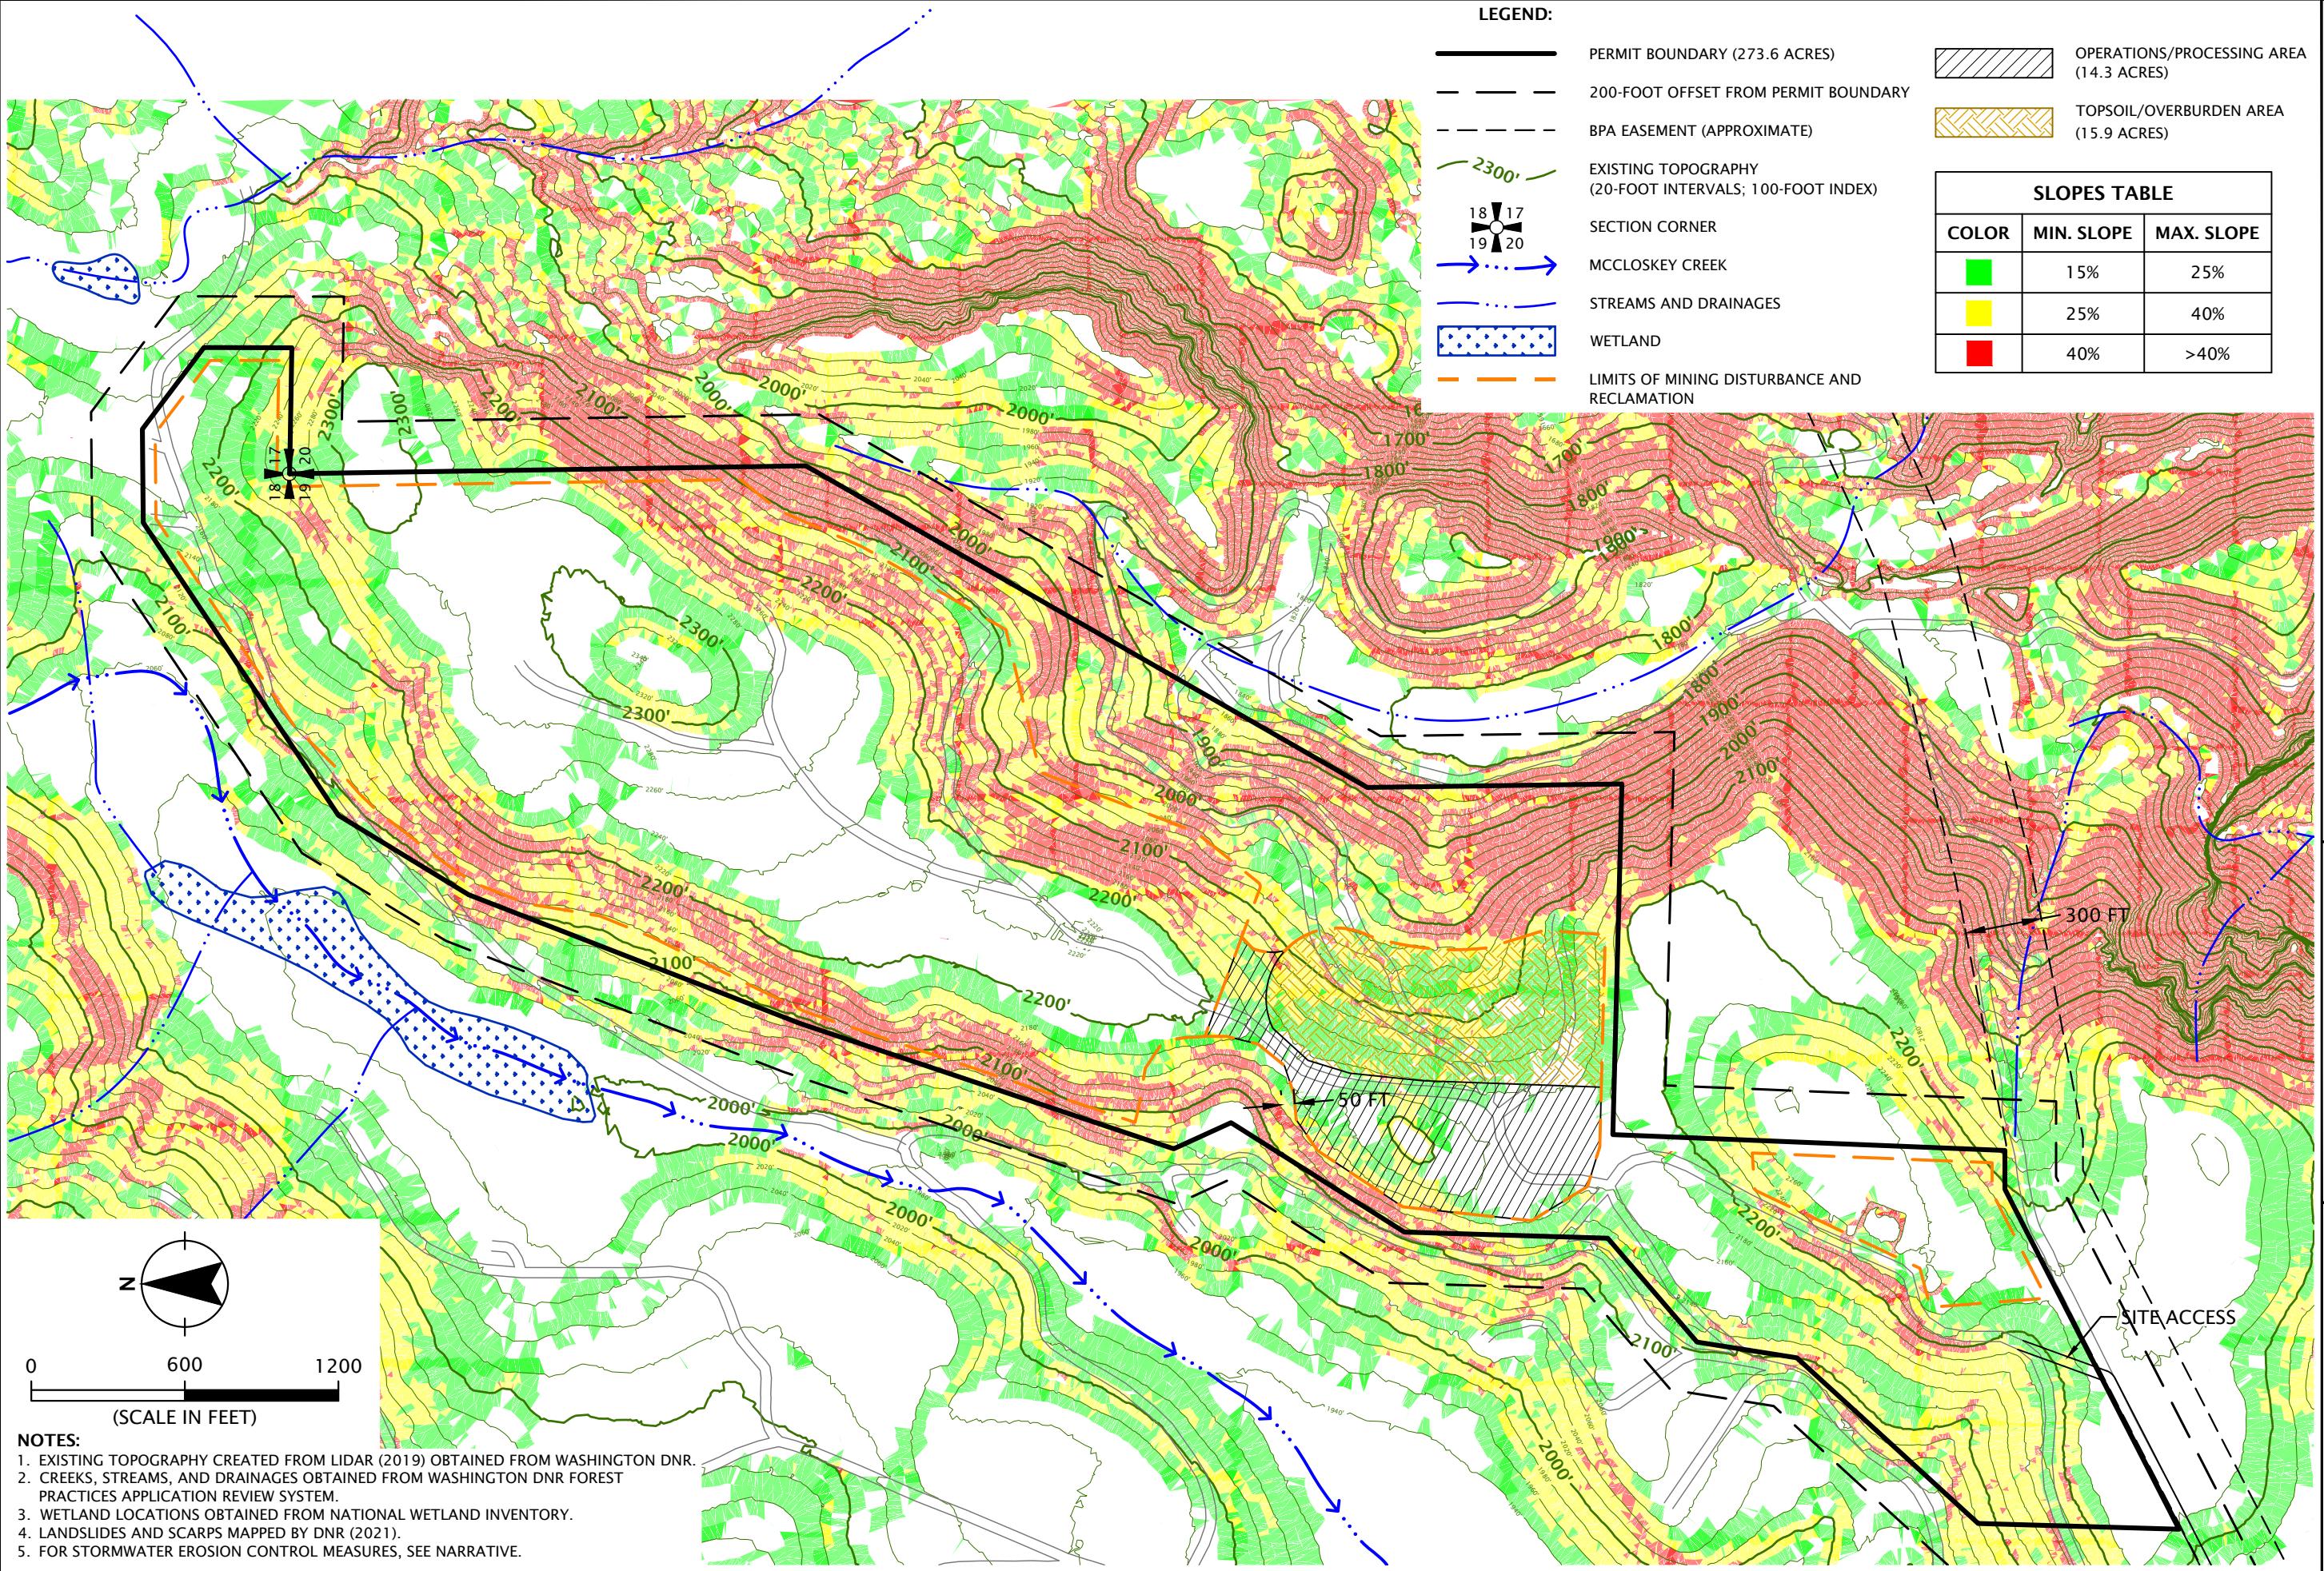
FIGURE 2

An engineering geologist from our office conducted a field reconnaissance on April 1, 2021 to observe the existing site characteristics. Slope gradients derived from LiDAR analysis of existing slopes are presented on Figure 2.

Much of the slopes along the eastern and western flanks of the northern ridge are 40 percent or greater, with the central and southern portions of the site generally showing slopes of 25 percent or less. Based on our observations of exposed soil and road cuts across the site, topsoil was observed to be approximately 2 feet thick, with subsoil of approximately 2 to 4 feet thick.

A temporary overburden and topsoil stockpile is proposed for the eastern-central sloped area shown on Figures 2 through 5. Vegetation should be cleared and topsoil removed from the area and separately stockpiled before the overburden soil is placed. Where the temporary stockpile will be placed over existing slopes greater than 15 percent, the ground surface should be graded into a benched geometry to avoid slide-plane development below the fill. Slopes for the temporary overburden and topsoil stockpile should be constructed at a gradient of 3H:1V or flatter, which is shown on Figure 5. This gradient is equivalent to the natural slope below the proposed fill location.

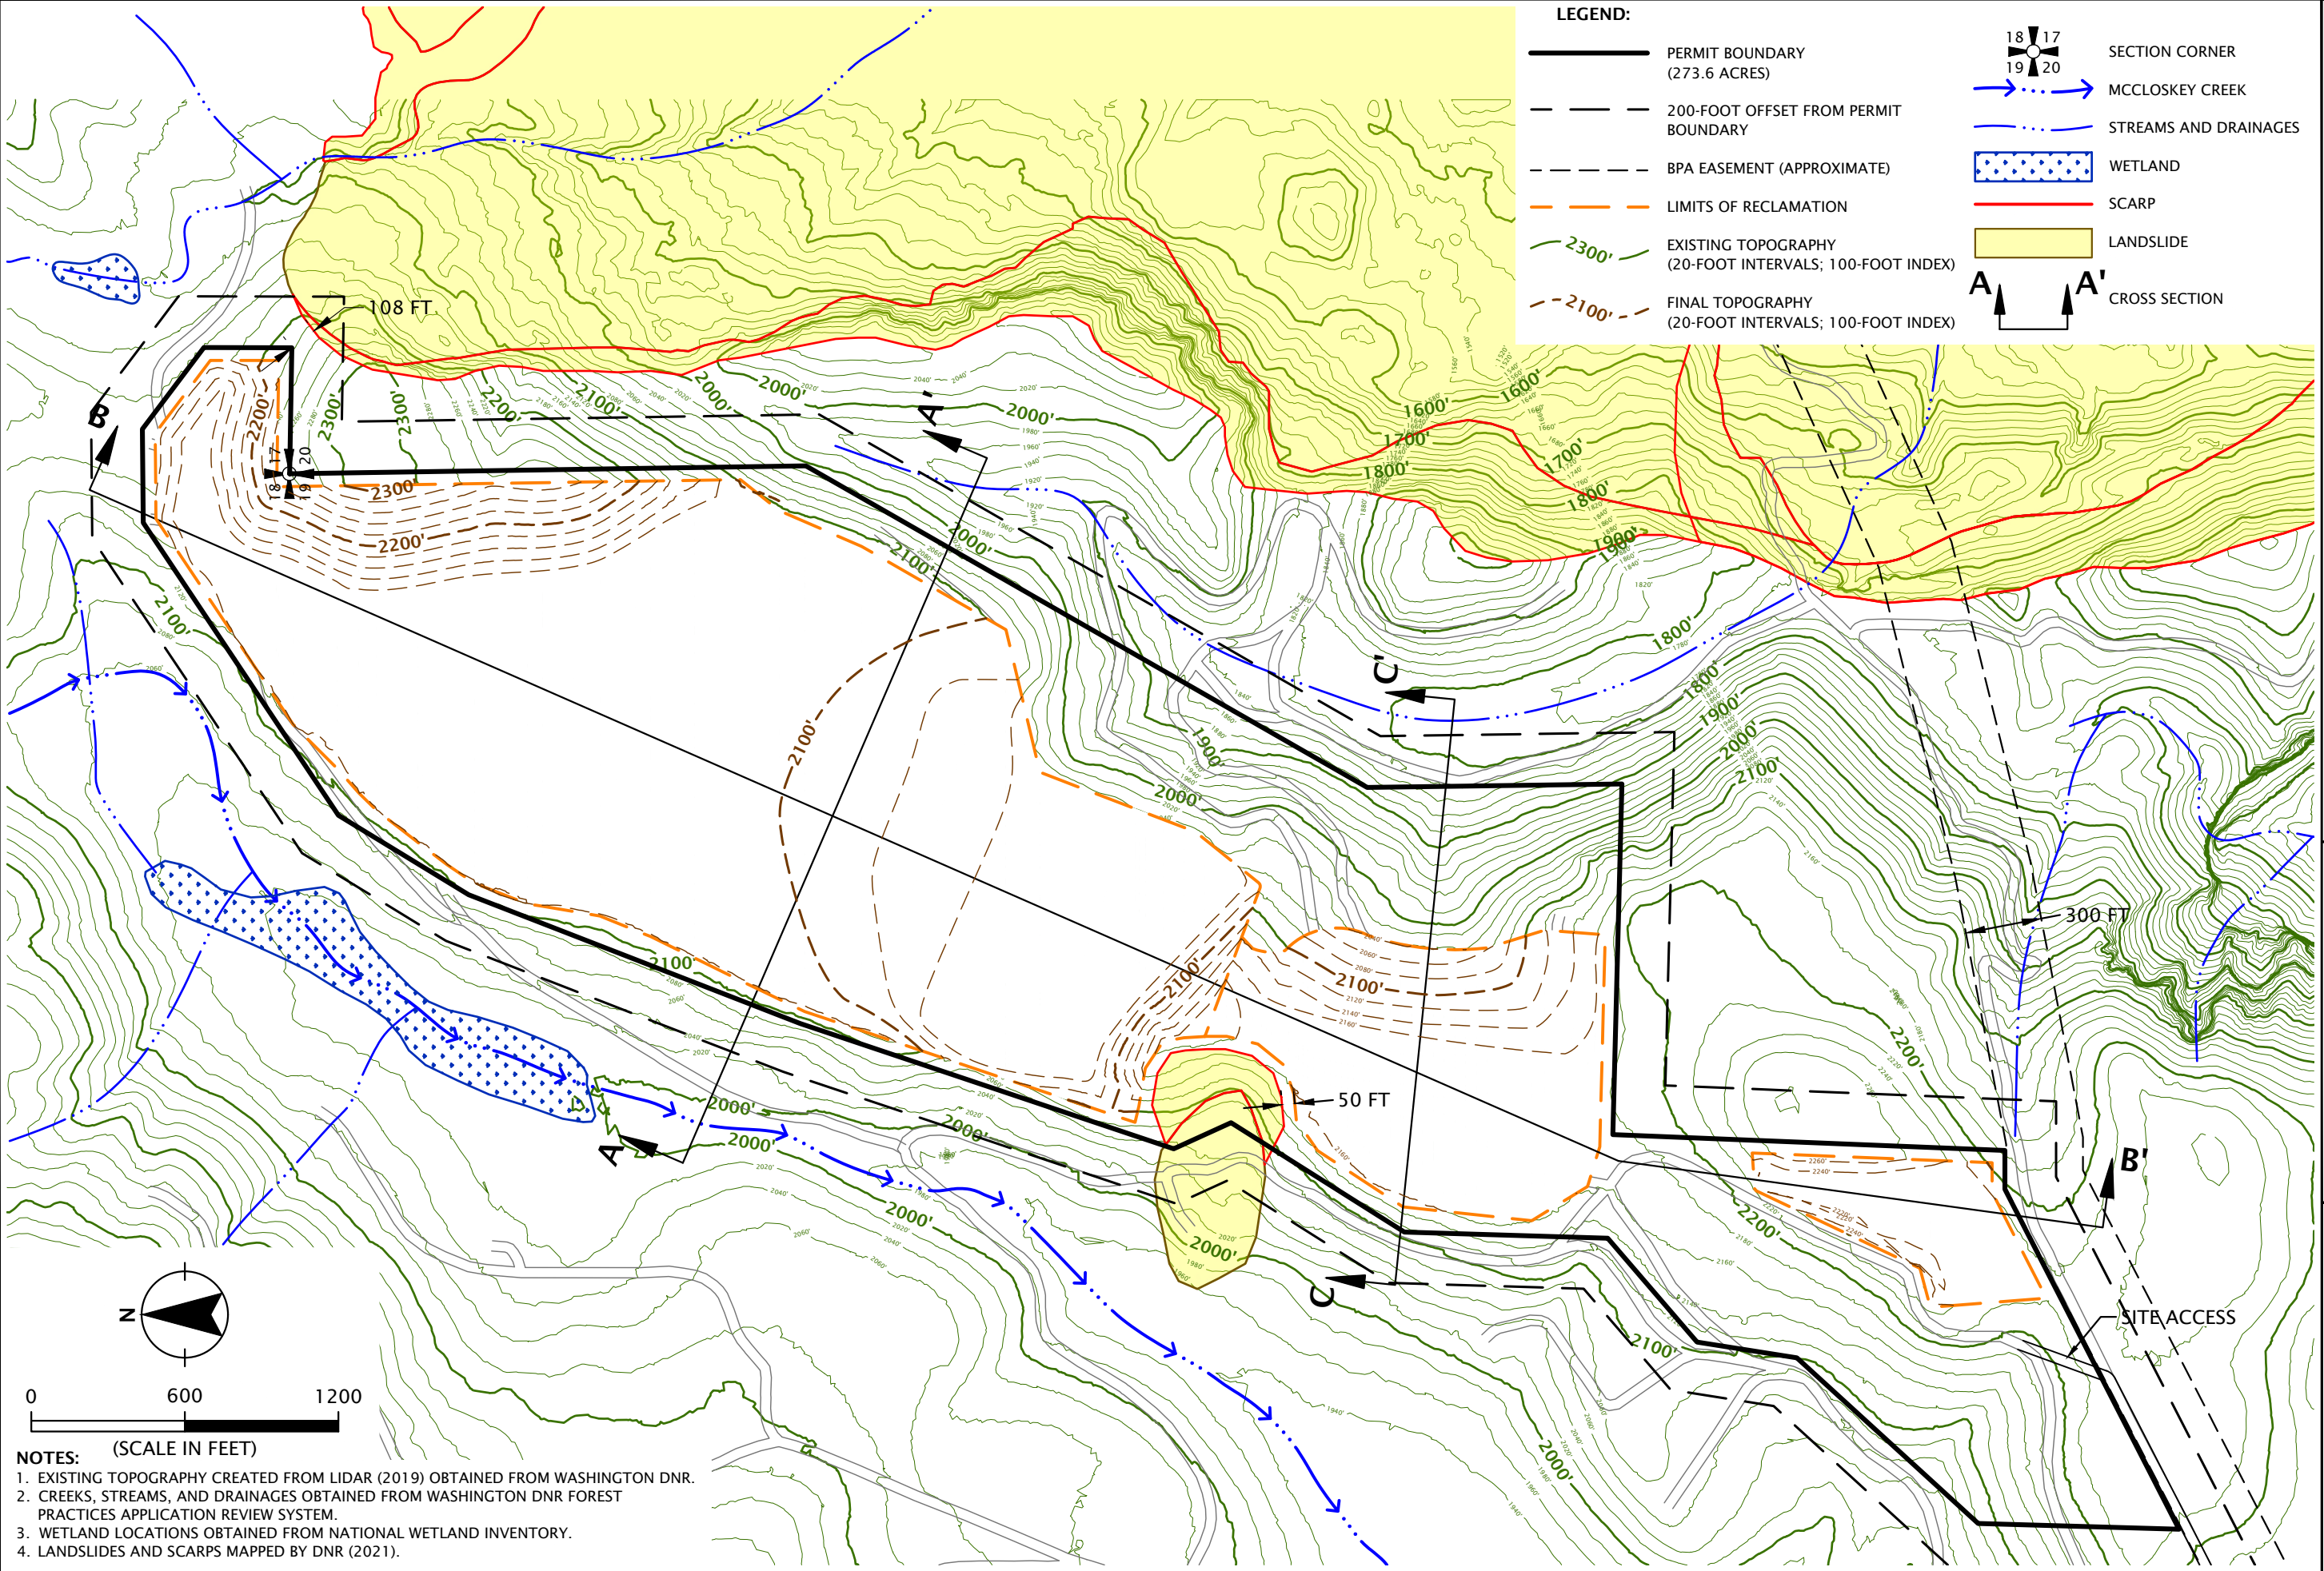
STOREDAHL & SONS, INC. STOREDAHL-12-01 AUGUST 2021	FINAL TOPOGRAPHY - LANDSLIDE HAZARD AREAS SKAMANIA QUARRY	FIGURE 4 SKAMANIA COUNTY, WA SECS. 17, 18, 19 & 30, TOWNSHIP 2N, RANGE 6E, W.M.
---	---	--

A small landslide is mapped by DNR on the western edge of the site, as shown on Figures 3 and 4. Our field observations confirmed the presence of the slide, and its mapped extent is generally accurate. The interpreted scarp and slide mass have been smoothed over by erosion, suggesting it is an ancient feature. We did not observe ground cracking or other indications of recent slide movement. Outcrop exposed by prior timber disturbance near the toe of the slide mass, as well as material excavated by animal burrows in the scarp and slide mass, consisted of tephra, volcanoclastic material, and large blocks of andesite. Based on the geologic mapping by Evarts and Fleck (2017) and their unit descriptions, we believe the slide is located near the northern edge of the structural horst that crosses the site, mapped as the upper member of the Eagle Creek Formation. A small water seep was observed at the toe of the slide.

We interpret the small landslide mapped on the western edge of the site to be an ancient feature that does not show indications of recent displacement. We recommend the proposed mine project avoid the headscarp area of this feature and not place materials near the headscarp, which could add weight and possibly cause retrogression of the scarp.

The proposed mine plan presented on Figures 2 through 5 follows our recommendations. A minimum 50-foot setback has been incorporated into the plan between the top of the small landslide headscarp to the proposed limits of the mine excavation and operations area to prevent mine activity from affecting the scarp. Additionally, grading of the operations area and mining in the northern portion of the site near this feature will be conducted by removing material, thus reducing potential driving forces for possible additional sliding.

Based on our observations of exposed basalt in the current timber pit and from extensive drilling of the site, benched highwalls in basalt bedrock are likely to be competent and stable over the life cycle of the mine. Final slopes for the proposed mine should be completed at gradients of 2H:1V as shown on Figures 4 and 5.

Stormwater from the mine disturbance area should be routed away from the top of steep slopes to avoid decreasing slope stability. Surface water drainage from the proposed topsoil storage and operations area should be routed to the northern mine excavation to the greatest extent possible and then to the mine floor. Stormwater in extraction areas should be directed to the interior of the mined excavation and then to the floor for infiltration. Figure 4 shows the final site topography at the completion of mining in accordance with these recommendations.
