GEOTECHNICAL INVESTIGATION & REPORT

WASHOUGAL RIVER ROAD
FANNING HILL SLIDE AT MP 13, CRP 1006.2 - PHASE I
SKAMANIA COUNTY, WASHINGTON

9-61M-10402-0

March 2000

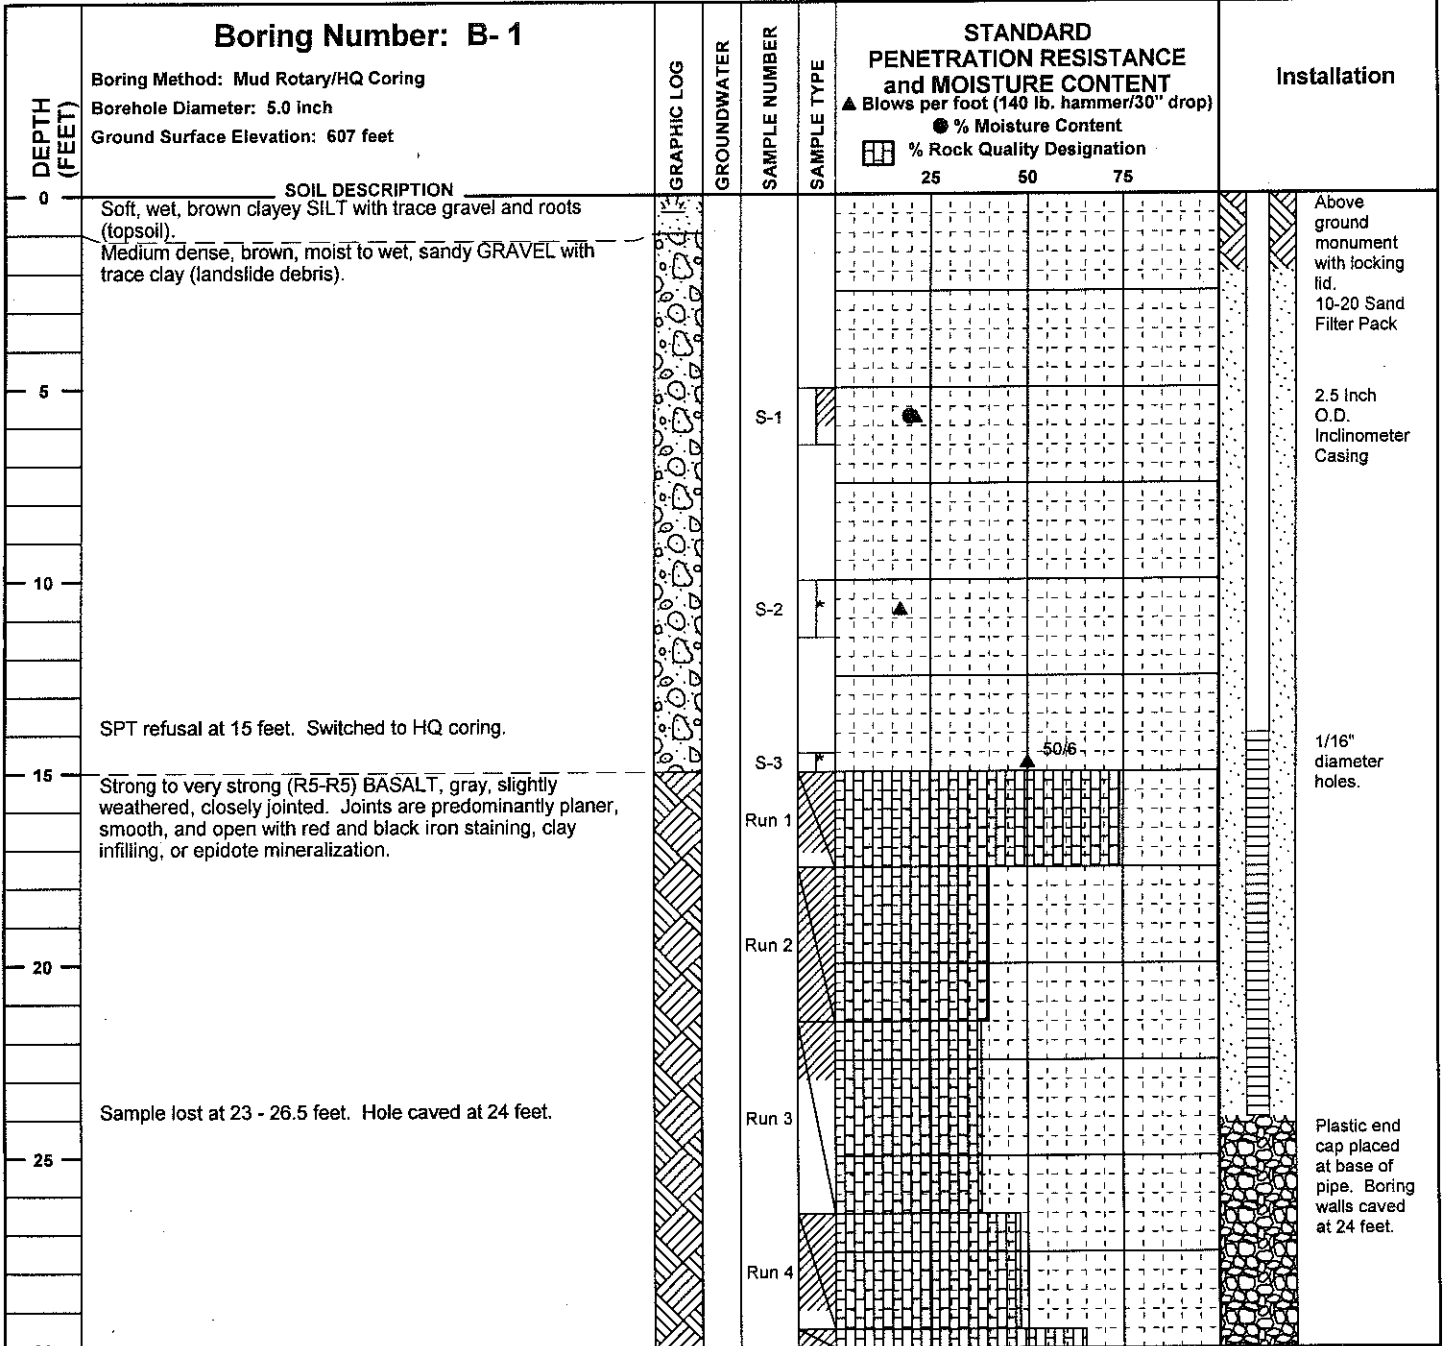
DEPTH (FEET)	Boring Number: B-1 Boring Method: Mud Rotary/HQ Coring Borehole Diameter: 5.0 inch Ground Surface Elevation: 607 feet	GRAPHIC LOG	GROUNDWATER	SAMPLE NUMBER	SAMPLE TYPE	STANDARD PENETRATION RESISTANCE and MOISTURE CONTENT			Installation
						Blows per foot (140 lb. hammer/30" drop)	% Moisture Content	% Rock Quality Designation	
						25	50	75	
30	SOIL DESCRIPTION Strong to very strong (R5-R5) BASALT, gray, slightly weathered, closely jointed. Joints are predominantly planar, smooth, and open with red and black iron staining, clay infilling, or epidote mineralization.			Run 5					
35	Boring terminated at 31.5 feet below ground surface. Slope indicator pipe installed from 0 to 26.5 feet below ground surface on 12/20/99. Groundwater was not observed.								
40									
45									
50									
55									
60

DEPTH (FEET)	SOIL DESCRIPTION	GRAPHIC LOG	GROUNDWATER	SAMPLE NUMBER	SAMPLE TYPE	STANDARD PENETRATION RESISTANCE and MOISTURE CONTENT			Installation
						Blows per foot (140 lb. hammer/30" drop)	% Moisture Content	% Rock Quality Designation	
						25	50	75	
0	Loose, wet, brown, clayey SAND with roots (topsoil).								Above ground monument with locking lid. 10-20 Sand Filter Pack
	Loose, moist, brown, coarse SAND with clay (old road fill).								
5									2.5 Inch O.D. Inclinator Casing
	Loss of circulation at 8 feet.								
	Loose, moist, brown sandy GRAVEL (landslide debris).			S-1	▲ ●				
10									2.5 Inch O.D. Inclinator Casing
	Loose, moist, dark gray to brown SAND and angular basalt GRAVEL.			S-2	●				
	Medium strong (R3) BASALT, dark gray, slightly weathered, fractured.			S-3	● ▲				
15									2.5 Inch O.D. Inclinator Casing
	Medium strong (R3) BASALT, dark gray, slightly weathered, fractured.			S-4	● ▲

Very slow drilling. Switched to HQ coring. Medium strong to very strong (R3-R5) BASALT, gray, slightly weathered, closely to very closely jointed. Joints are predominantly planar, smooth, and open with epidote mineralization or red and black iron staining.			Run 1					
20									2.5 Inch O.D. Inclinator Casing
				Run 2					
25									2.5 Inch O.D. Inclinator Casing
30									2.5 Inch O.D. Inclinator Casing

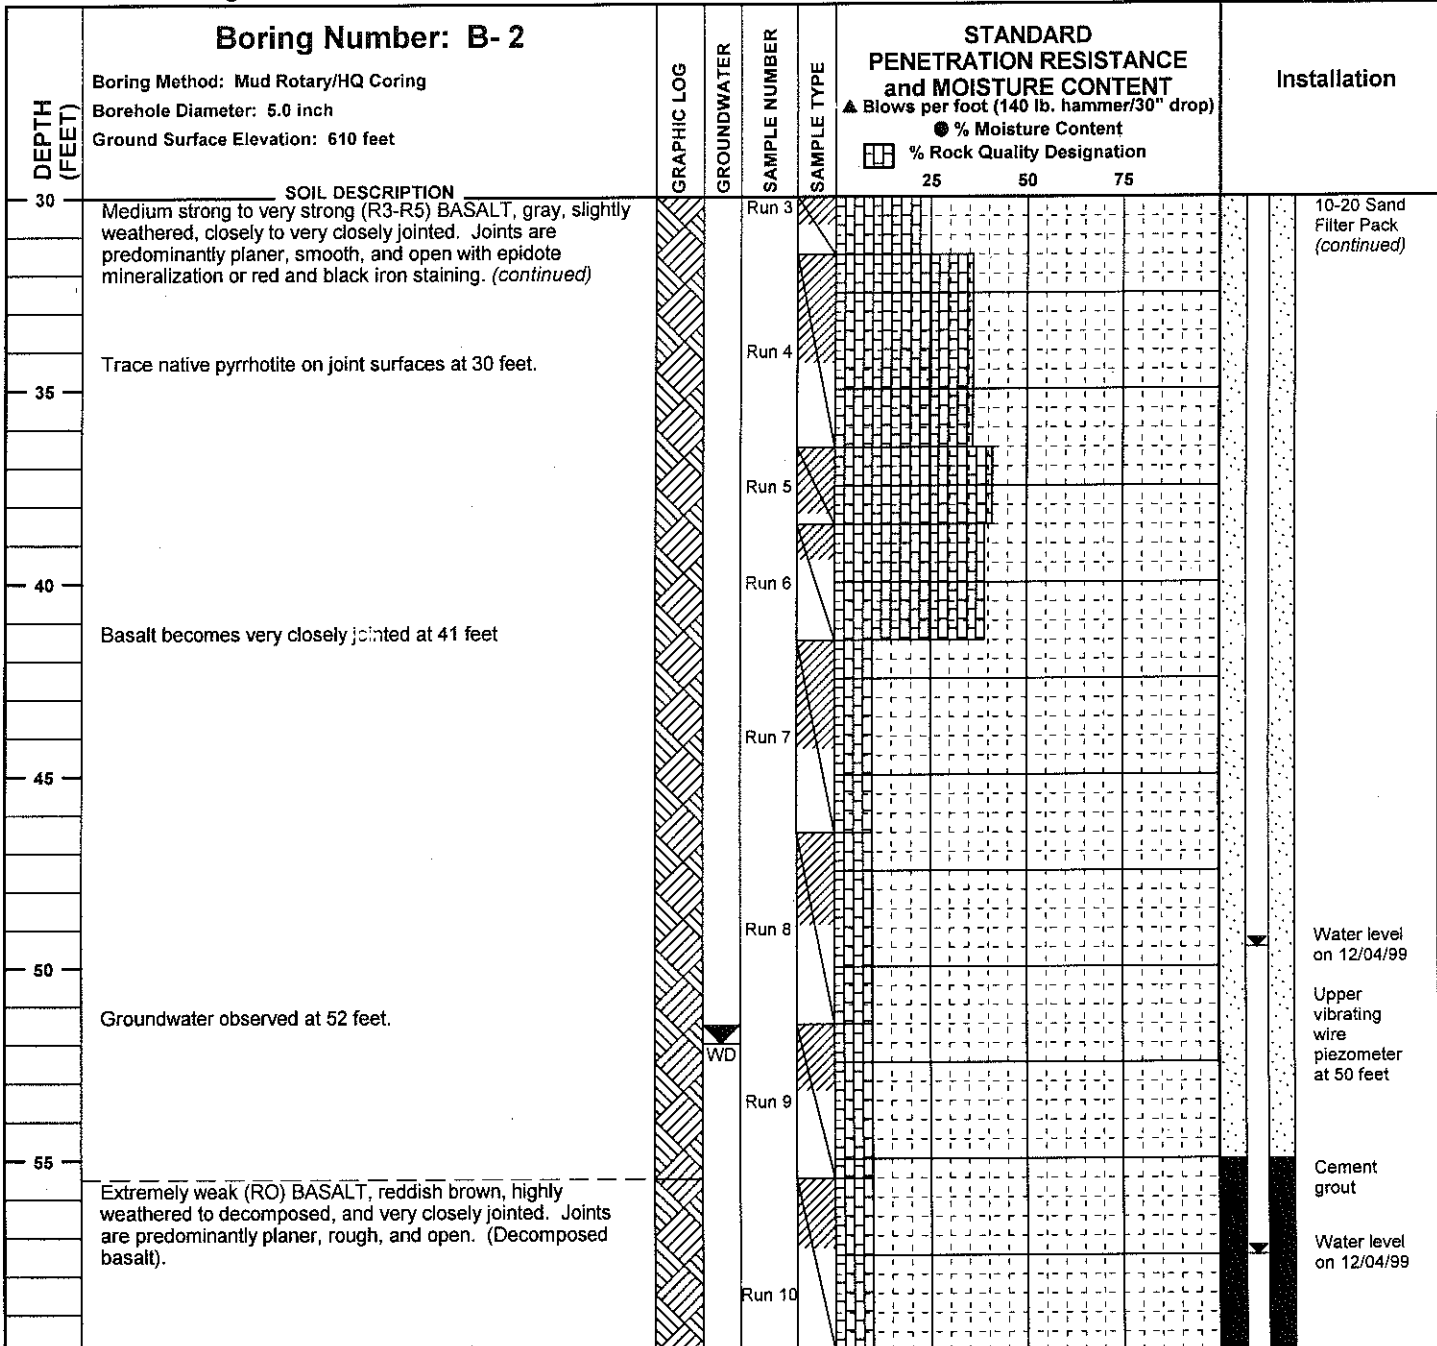
DEPTH (FEET)	Boring Number: B-2 Boring Method: Mud Rotary/HQ Coring Borehole Diameter: 5.0 inch Ground Surface Elevation: 610 feet	GRAPHIC LOG	GROUNDWATER	SAMPLE NUMBER	SAMPLE TYPE	STANDARD PENETRATION RESISTANCE and MOISTURE CONTENT			Installation
						Blows per foot (140 lb. hammer/30" drop)	% Moisture Content	% Rock Quality Designation	
	SOIL DESCRIPTION					25	50	75	
60	Extremely weak (R0) BASALT, dark gray to reddish brown, mottled. Highly weathered basalt fragments in a sandy clay matrix. (Decomposed basalt).				*				Cement grout (continued)
65	Very dense, moist, gray to brown, clayey SAND with trace gravel. Blocky structure with volcanic and sedimentary clasts with weak to moderate cementation. (Volcanic debris flow). Very dense, damp, reddish brown, clayey SAND with trace gravel. Blocky structure with moderate to strong cementation. Contains coarse sand to fine gravel, subangular to subrounded, and moderately to well-graded. Has "baked" appearance.			Run 11

70	Dense, damp, black, silty CLAY, moderately cemented, high charcoal content. Landslide slip contact between a depth of 69 to 70 feet below ground surface. Weak (R2) VOLCANIC BRECCIA, green to reddish brown, very thinly bedded fine sand and clay with flow banding. Hydrothermally altered with abundant chlorite. Slickensides observed at 70 feet. (Altered flow breccia). Weak to medium strong (R2-R3) VOLCANIC TUFF, green, thin bedded, coarse to fine sand and silt. Hydrothermally altered with abundant chlorite.			Run 12					
75	Strong to very strong (R4-R5) BASALT, green, slightly weathered, highly vesicular and closely jointed. Vesicles are partially filled with chlorite. Joints and fractures are predominantly planar and rough.			Run 13					Lower vibrating wire piezometer at 72 feet
80	Hydrothermally altered with abundant chlorite and epidote. Trace native pyrrhotite on joints and fractures.			Run 14

85	Some fractures are healed with calcite and silica mineral infilling. (Vesicular basalt). Grades to gray vesicular basalt with trace to some vesicle infilling at base of boring.			Run 15					Plastic end cap placed at base of pipe. Boring caved at 83 feet.
90	Boring terminated at 86.5 feet below ground surface. Slope indicator pipe installed from 0 to 83 feet below ground surface on 12/15/99.

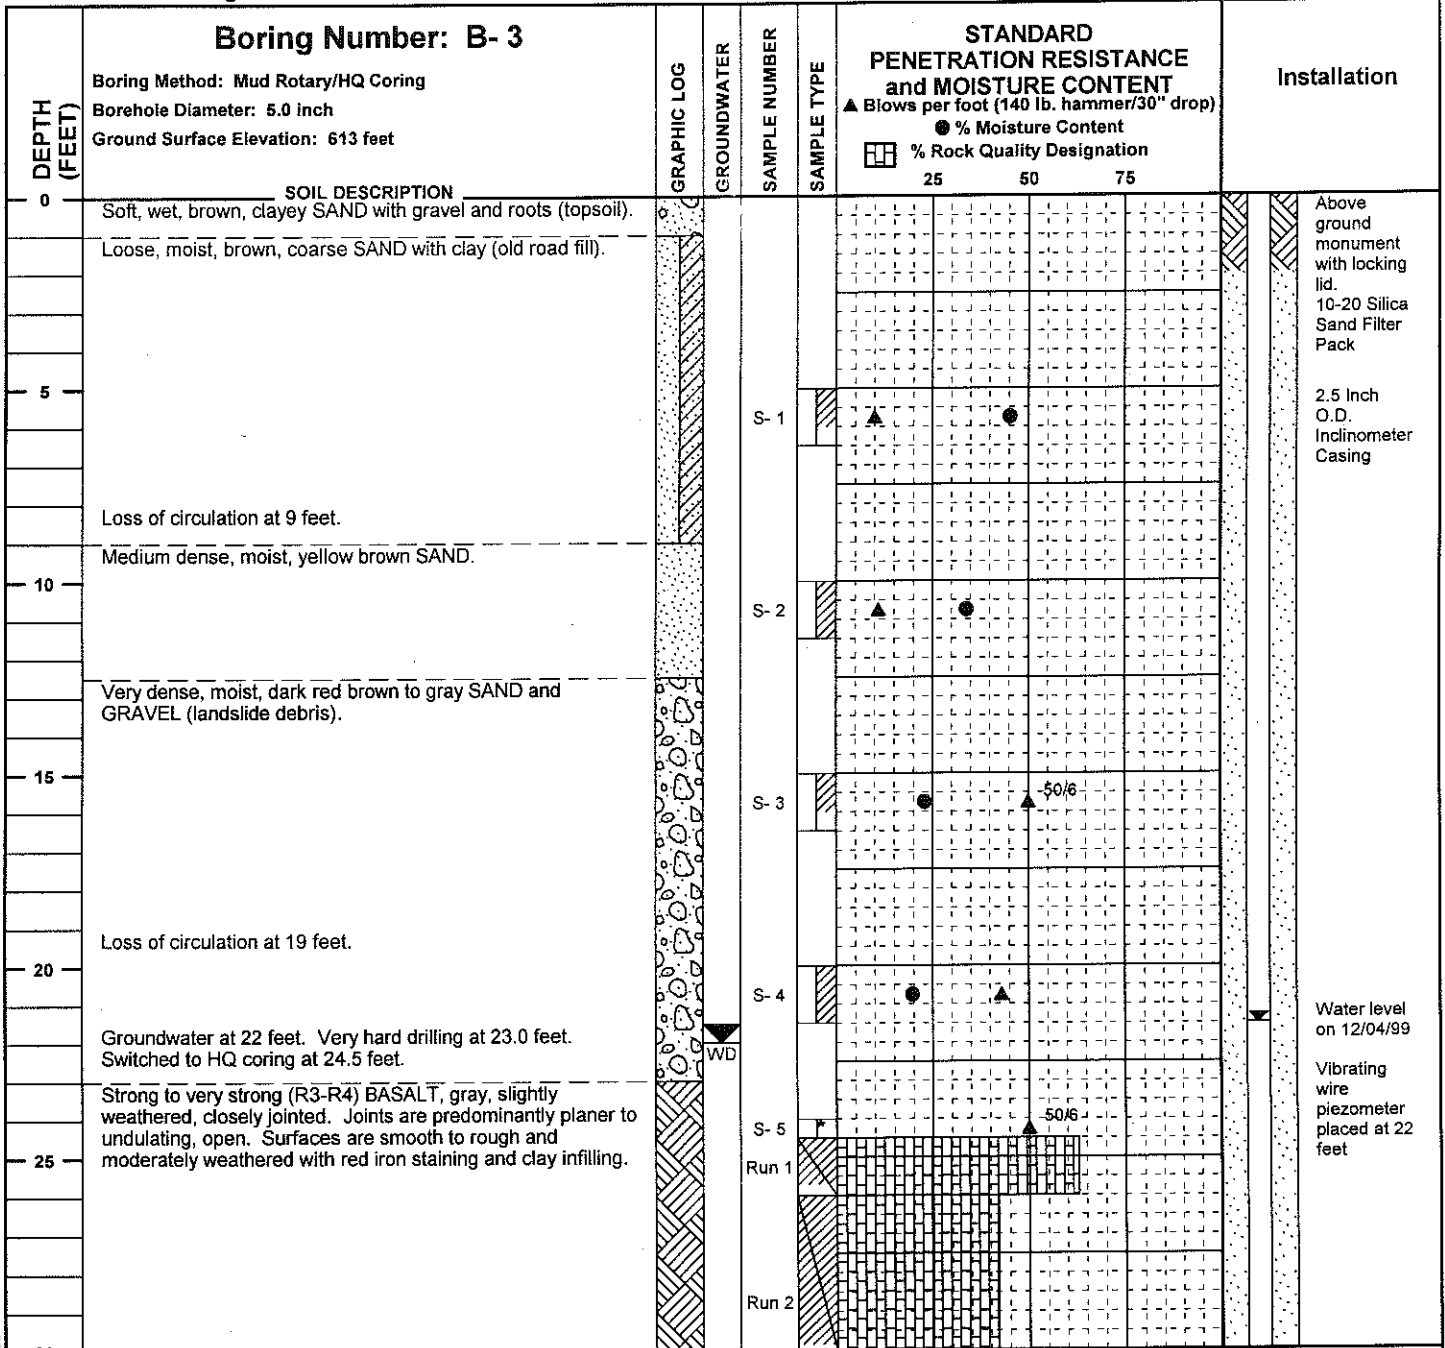
DEPTH (FEET)	Boring Number: B-3 Boring Method: Mud Rotary/HQ Coring Borehole Diameter: 5.0 inch Ground Surface Elevation: 613 feet	GRAPHIC LOG	GROUNDWATER	SAMPLE NUMBER	SAMPLE TYPE	STANDARD PENETRATION RESISTANCE and MOISTURE CONTENT			Installation
						Blows per foot (140 lb. hammer/30" drop)	% Moisture Content	% Rock Quality Designation	
						25	50	75	
30	Strong to very strong (R3-R4) BASALT, gray, slightly weathered, closely jointed. Joints are predominantly planar to undulating, open. Surfaces are smooth to rough and moderately weathered with red iron staining and clay infilling. Extremely weak (RO) BASALT, red brown, highly weathered, and closely fractured. Rock fabric is iron-stained and minerals are highly altered. (Decomposed Basalt)			Run 3					10-20 Silica Sand Filter Pack (continued)
35									
40	Boring terminated at 41 feet below ground surface. Slope indicator pipe installed from 0 to 38 feet below ground surface on 12/14/99.			Run 4					Plastic end cap placed at base of pipe. Boring caved at 38 feet.

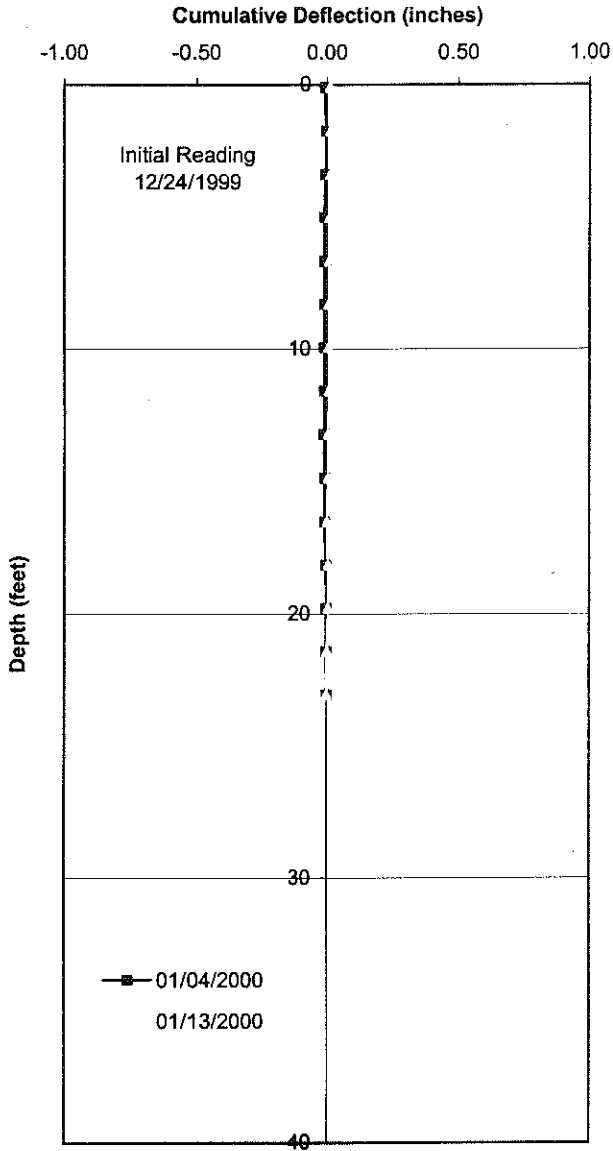
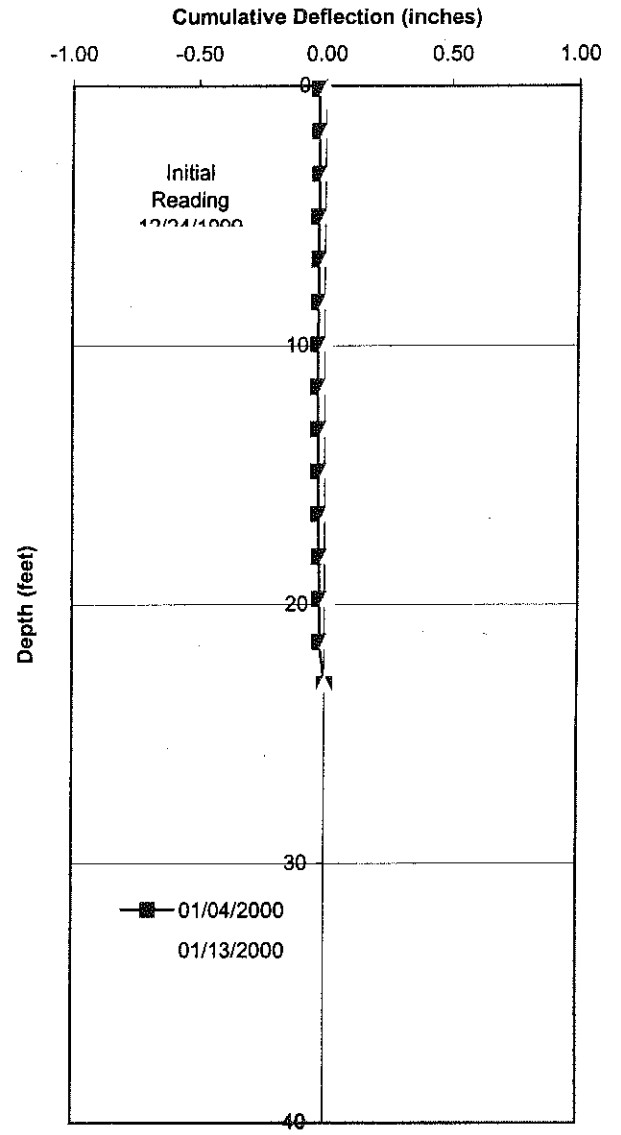
FIGURE A6

Deflection, A axis

Deflection, B axis
